**Flood Control Project Maintenance
Levee Inspections**

Fall 2009 Levee Maintenance Deficiency Summary Report

American River Flood Control District

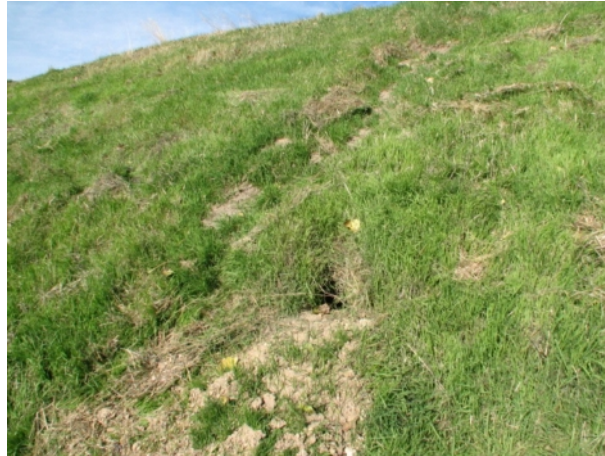
Levee Mile Report Line	2
Start Levee Mile	0.10
End Levee Mile	0.10
Location	Land Side
Category	Earthen Levee
Item	Animal Control

Photo of active rodent hole near LM 0.10

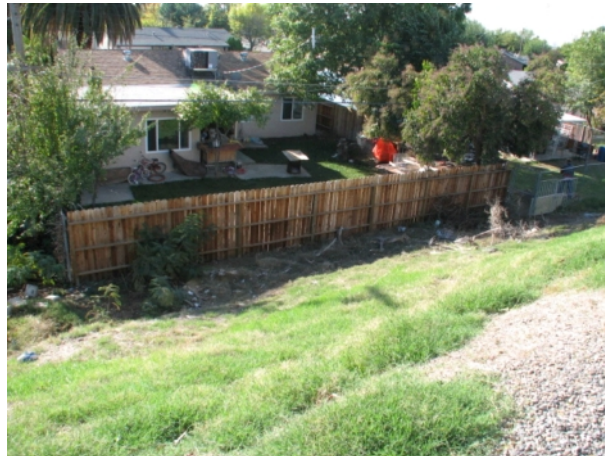
Levee Mile Report Line	10
Start Levee Mile	0.81
End Levee Mile	0.81
Location	Land Side
Category	Earthen Levee
Item	Slope Stability

10	0.81	0.81	Earthen Levee	Slope Stability	LS	M	Repair the levee slope damaged by foot traffic and prevent access where possible.	38.624305 ° -121.454506 °	38.624305 ° -121.454506 °	42 Y
11	1.05	1.05	Earthen Levee	Encroachments	LS	M	Debris Inspector Comments: Fence posts and footings left along levee toe.	38.625048 ° -121.450389 °	38.625048 ° -121.450389 °	41 Y
12	1.09	1.09	Earthen Levee	Encroachments	LS	M	Debris Inspector Comments: Concrete rubble left along levee toe.	38.624943 ° -121.449663 °	38.624943 ° -121.449663 °	40
13	1.14	1.14	Earthen Levee	Encroachments	LS	PO	Fences Inspector Comments: Dog-eared wooden fence is built against the levee slope. Fence is partially fallen near swimming pool.	38.624800 ° -121.448808 °	38.624800 ° -121.448808 °	24 Y
14	1.16	1.16	Earthen Levee	Encroachments	LS	CO	Fences Inspector Comments: Dog-eared wooden fence and chain link fence is built against the levee slope.	38.624832 ° -121.448607 °	38.624832 ° -121.448607 °	23

Photo of levee slope damage caused by foot traffic.

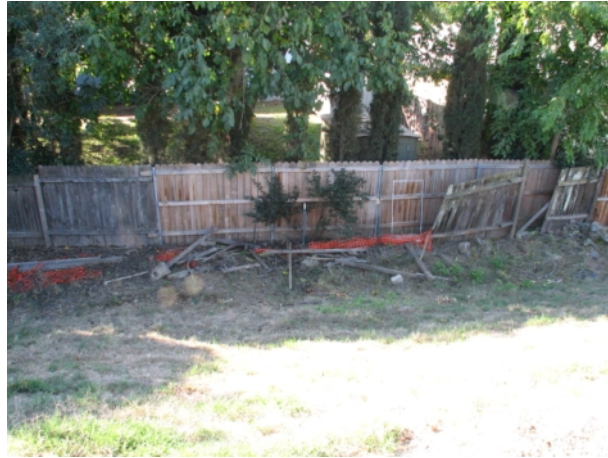
Levee Mile Report Line	13
Start Levee Mile	1.14
End Levee Mile	1.14
Location	Land Side
Category	Earthen Levee
Item	Encroachments

Photo of damaged wooden fence.

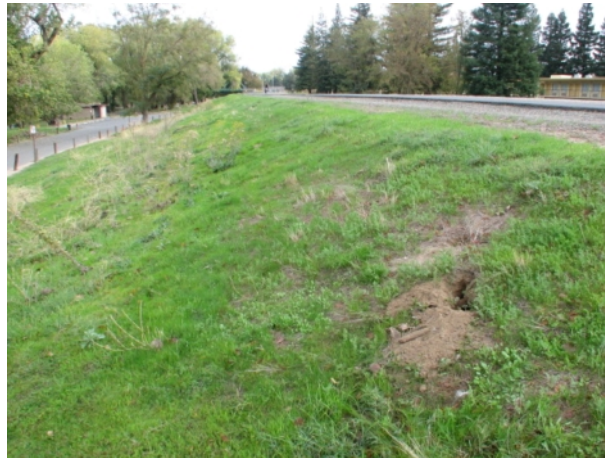
Levee Mile Report Line	1
Start Levee Mile	0.02
End Levee Mile	0.02
Location	Water Side
Category	Earthen Levee
Item	Animal Control
Active rodent burrows present on the waterside slope.	
jpaasch_20091109_190.jpg

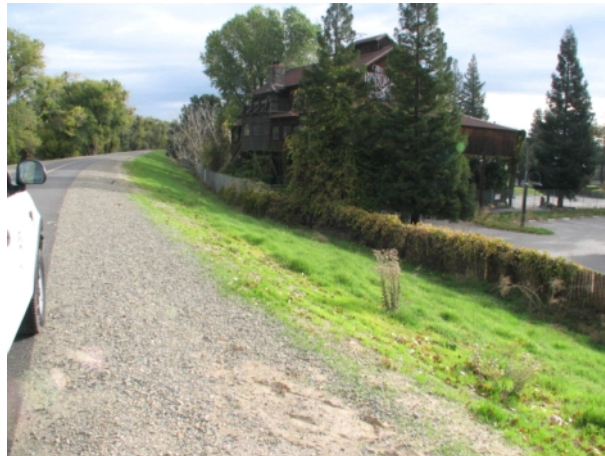
Levee Mile Report Line	3
Start Levee Mile	0.31
End Levee Mile	0.47
Location	Land Side
Category	Earthen Levee
Item	Encroachments
Landscaping on privacy fence within 10-ft of the levee toe limits access and visibility.	
jpaasch_20091109_191.jpg

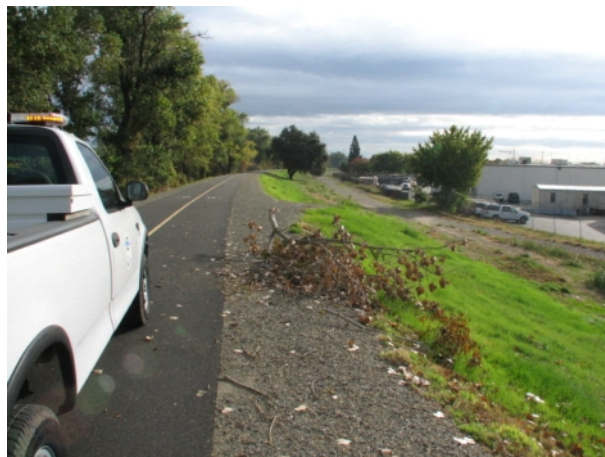
Levee Mile Report Line	4
Start Levee Mile	0.72
End Levee Mile	0.72
Location	Land Side
Category	Earthen Levee
Item	Encroachments
Tree limbs present on landside hinge point should be removed.	
jpaasch_20091109_192.jpg

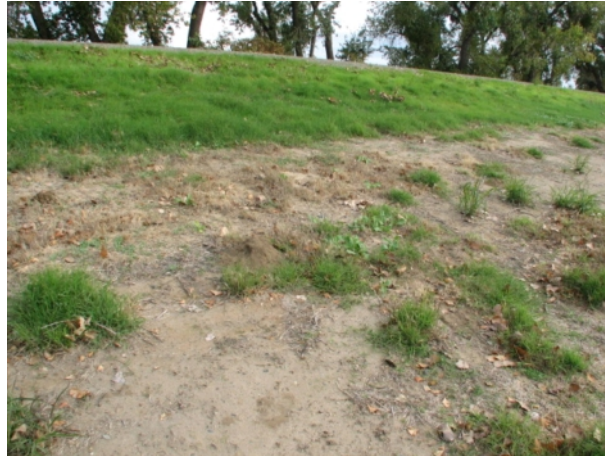
Levee Mile Report Line	5
Start Levee Mile	0.82
End Levee Mile	0.82
Location	Land Side
Category	Earthen Levee
Item	Animal Control
Numerous active animal burrows present on levee slope near the lower patrol road.	
jpaasch_20091109_193.jpg

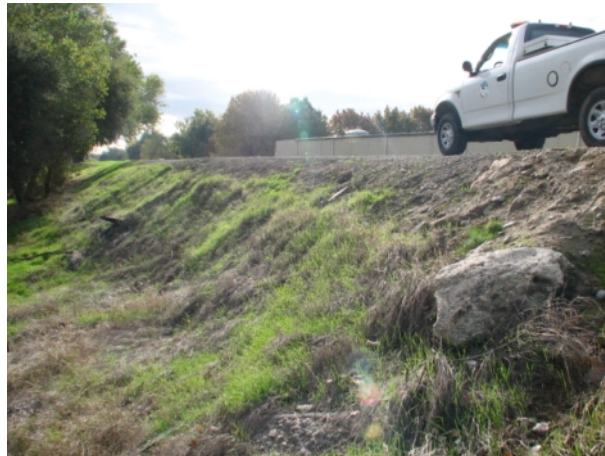
Levee Mile Report Line	6
Start Levee Mile	1.42
End Levee Mile	1.42
Location	Water Side
Category	Earthen Levee
Item	Animal Control
Numerous active animal burrows present on the waterside slope of the levee.	
jpaasch_20091109_194.jpg

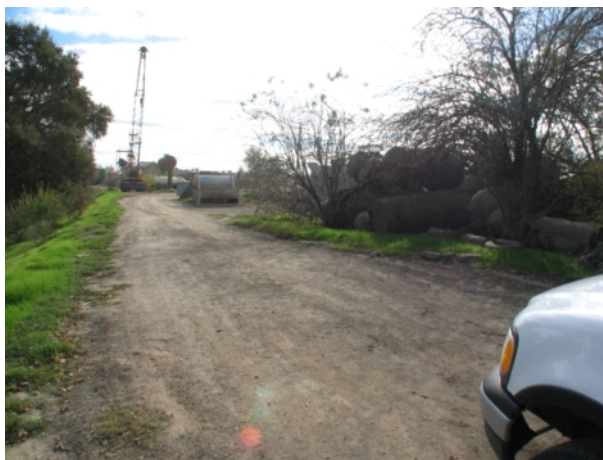
Levee Mile Report Line	10
Start Levee Mile	2.73
End Levee Mile	2.86
Location	Land Side
Category	Earthen Levee
Item	Encroachments
Abandoned vehicles, debris and materials have been placed landside of the levee crown.	
jpaasch_20091109_196.jpg

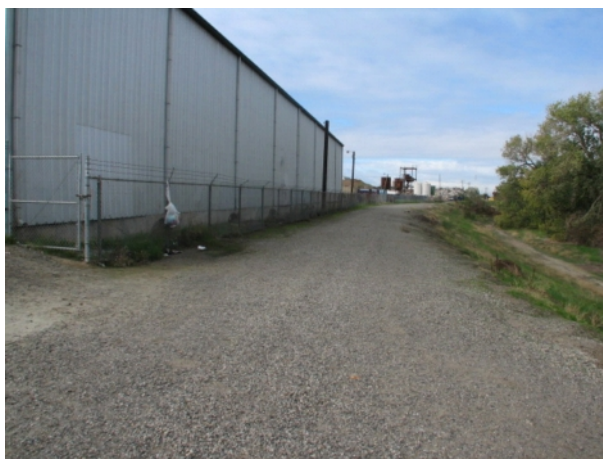
Levee Mile Report Line	13
Start Levee Mile	2.92
End Levee Mile	2.96
Location	Land Side
Category	Earthen Levee
Item	Encroachments
Building is placed just off the levee crown.	
jpaasch_20091109_197.jpg

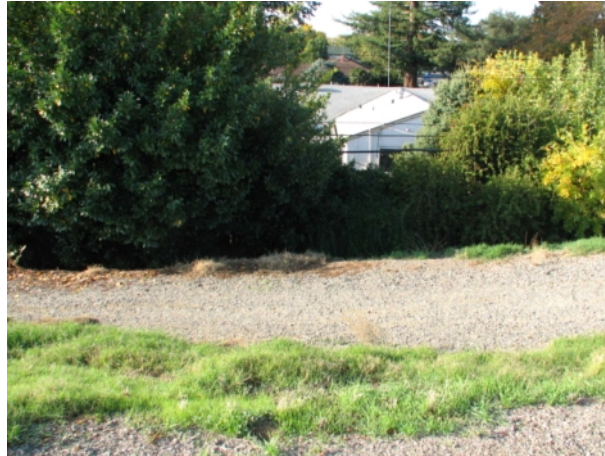
Levee Mile Report Line	15
Start Levee Mile	3.90
End Levee Mile	3.90
Location	Land Side
Category	Earthen Levee
Item	Encroachments
Landscaping within 10-ft of the landside toe obstructs access and visibility.	
jpaasch_20091116_209.jpg

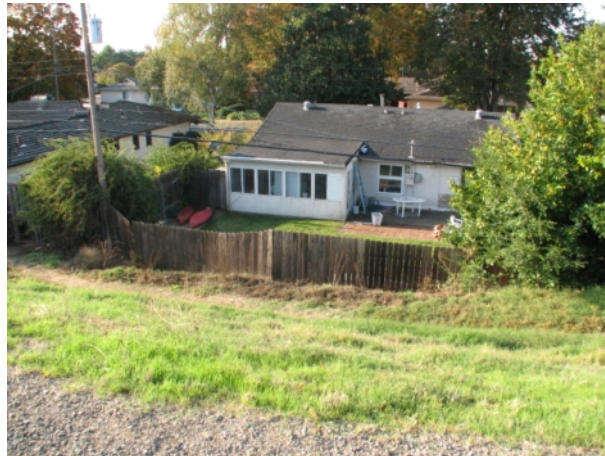
Levee Mile Report Line	17
Start Levee Mile	3.91
End Levee Mile	3.91
Location	Land Side
Category	Earthen Levee
Item	Encroachments
Privacy fence within 10-ft of landside toe obstructs access and visibility.	
jpaasch_20091116_208.jpg

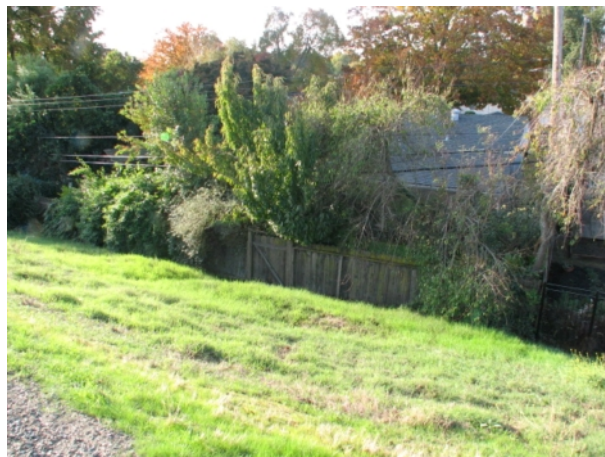
Levee Mile Report Line	19
Start Levee Mile	3.94
End Levee Mile	3.94
Location	Land Side
Category	Earthen Levee
Item	Encroachments
Fence and landscaping within 10-ft of levee toe obstructs access and visibility.	
jpaasch_20091116_211.jpg

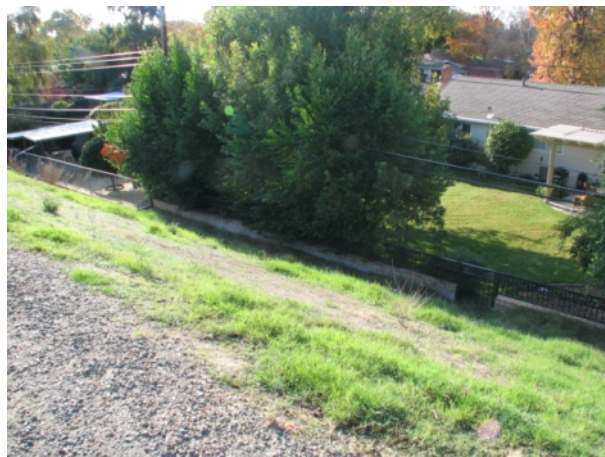
Levee Mile Report Line	35
Start Levee Mile	4.15
End Levee Mile	4.15
Location	Land Side
Category	Earthen Levee
Item	Encroachments
Fence and landscaping within 10-ft of levee toe obstructs access and visibility.	
jpaasch_20091116_214.jpg

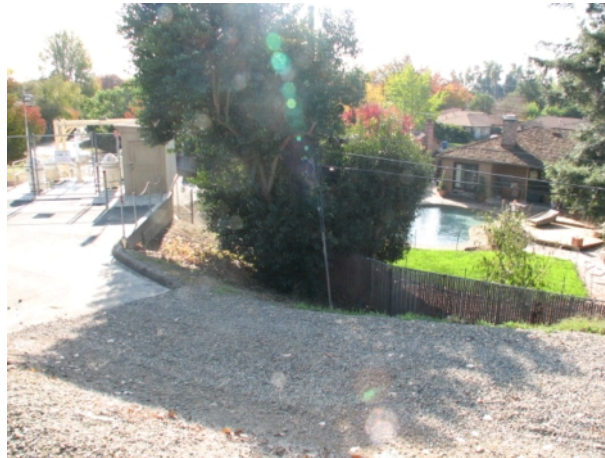
Levee Mile Report Line	61
Start Levee Mile	4.57
End Levee Mile	4.57
Location	Land Side
Category	Earthen Levee
Item	Encroachments
Fence and landscaping within 10-ft of levee toe obstructs access and visibility.	
jpaasch_20091116_218.jpg

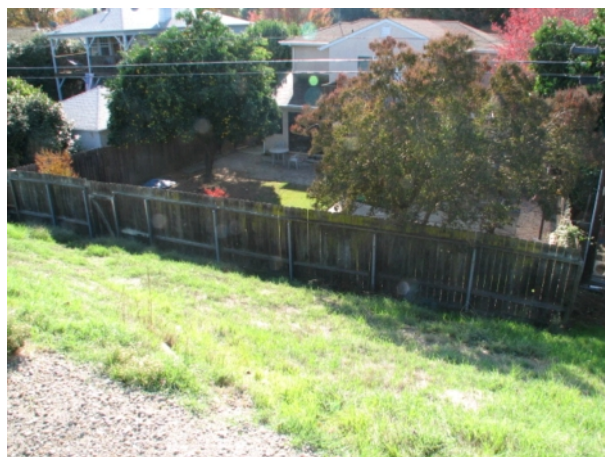
Levee Mile Report Line	67
Start Levee Mile	4.73
End Levee Mile	4.73
Location	Land Side
Category	Earthen Levee
Item	Encroachments
Fence within 10-ft of levee toe obstructs access and visibility.	
jpaasch_20091116_220.jpg

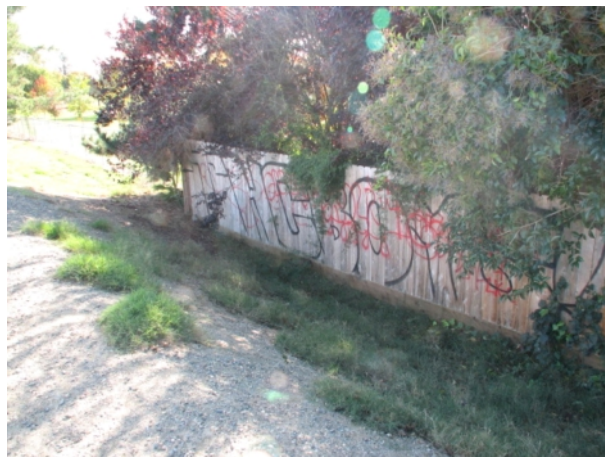
Levee Mile Report Line	83
Start Levee Mile	5.17
End Levee Mile	5.17
Location	Land Side
Category	Earthen Levee
Item	Encroachments
Fence and landscaping within 10-ft of levee toe obstructs access and visibility.	
jpaasch_20091116_222.jpg

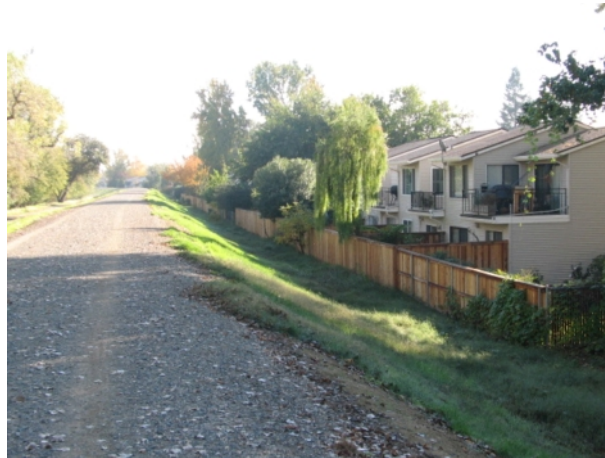
Levee Mile Report Line	117
Start Levee Mile	7.70
End Levee Mile	7.73
Location	Land Side
Category	Earthen Levee
Item	Encroachments
Wooden privacy fence within 10-ft of landside levee toe.	
jpaasch_20091119_230.jpg

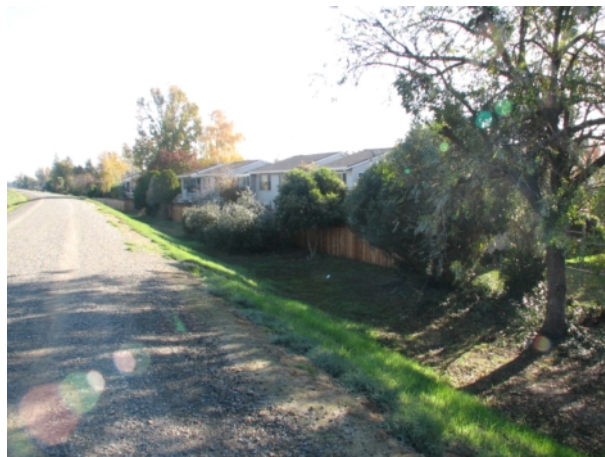
Levee Mile Report Line	122
Start Levee Mile	7.91
End Levee Mile	7.94
Location	Land Side
Category	Earthen Levee
Item	Encroachments
Wooden privacy fence and some landscape plantings are within 10-ft of the landside levee toe.	
jpaasch_20091119_231.jpg

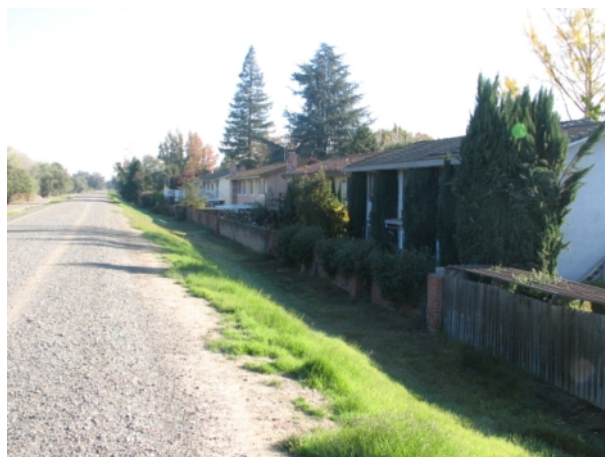
Levee Mile Report Line	130
Start Levee Mile	8.09
End Levee Mile	8.09
Location	Land Side
Category	Earthen Levee
Item	Encroachments
Privacy fence obstructs access and visibility.	
jpaasch_20091119_232.jpg

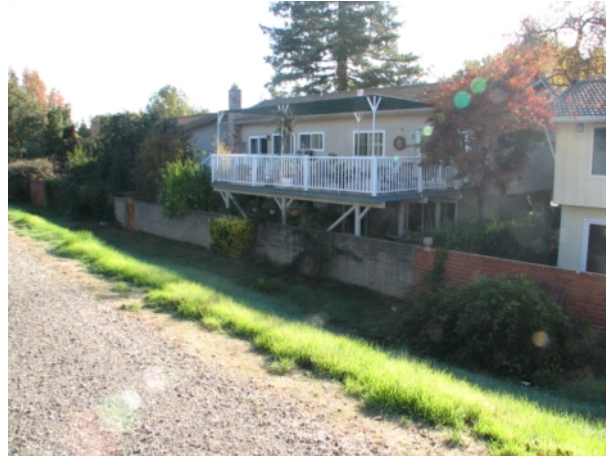
Levee Mile Report Line	134
Start Levee Mile	8.14
End Levee Mile	8.14
Location	Land Side
Category	Earthen Levee
Item	Encroachments
Privacy fence is within 10-ft of landside levee toe.	
jpaasch_20091119_233.jpg

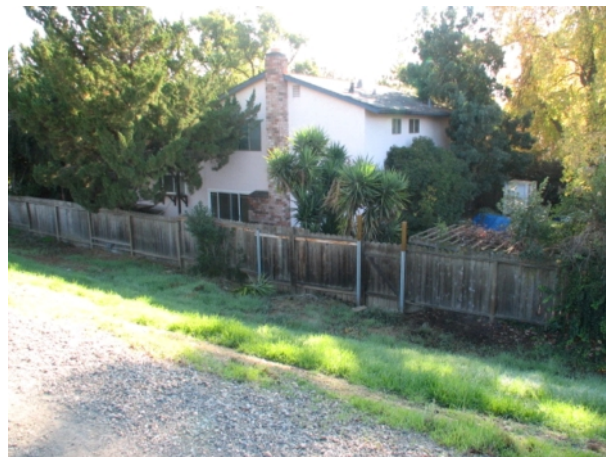
Levee Mile Report Line	137
Start Levee Mile	8.20
End Levee Mile	8.20
Location	Land Side
Category	Earthen Levee
Item	Encroachments
Privacy fence is within 10-ft of landside levee toe.	
jpaasch_20091119_234.jpg

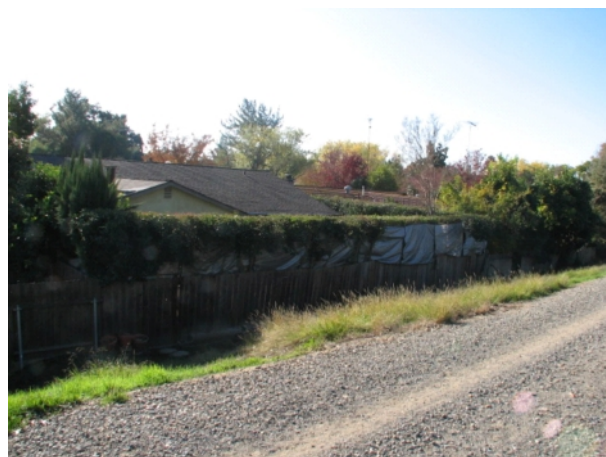
Levee Mile Report Line	142
Start Levee Mile	8.27
End Levee Mile	8.27
Location	Land Side
Category	Earthen Levee
Item	Encroachments
Fence, hedge and tarps within 10-ft of the levee toe obstruct access and visibility.	
jpaasch_20091119_239.jpg

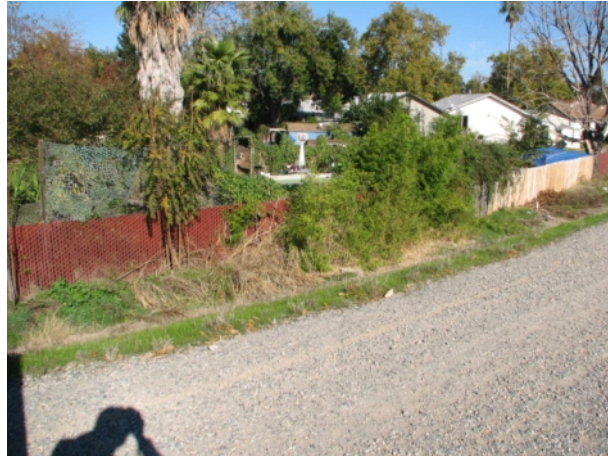
Levee Mile Report Line	12
Start Levee Mile	1.56
End Levee Mile	1.56
Location	Land Side
Category	Earthen Levee
Item	Encroachments
Privacy fence within 10-ft of the levee toe obstructs visibility and access. Landscaping should be trimmed and prunings removed.	
jpaasch_20091104_161.jpg

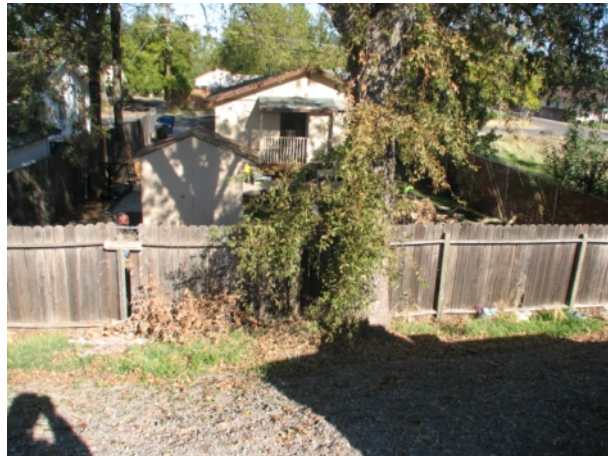
Levee Mile Report Line	15
Start Levee Mile	1.62
End Levee Mile	1.62
Location	Land Side
Category	Earthen Levee
Item	Encroachments
Privacy fence and landscaping within 10-ft of the levee toe obstructs visibility and access.	
jpaasch_20091104_160.jpg

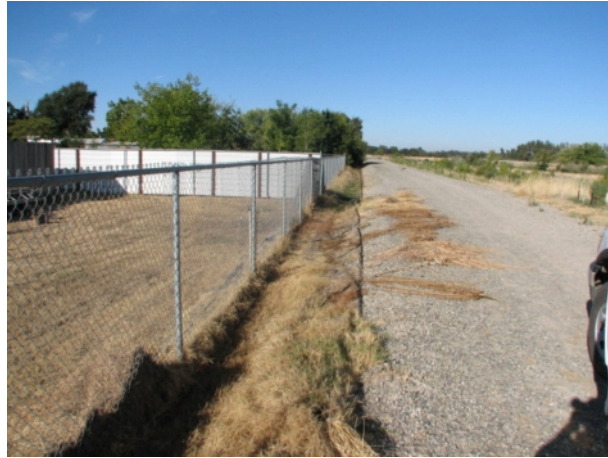
6	1.26	1.32	Earthen Levee	Encroachments	LS	PO	Fences Inspector Comments: Barbed wire fence runs along the levee toe.	38.662672 ° -121.431672 °	38.661823 ° -121.431678 °	2 Y
7	1.35	1.35	Earthen Levee	Encroachments	LS	M	Debris Inspector Comments: Rusty metal sheets located within landside drainage area.	38.661665 ° -121.431343 °	38.661665 ° -121.431343 °	1

Levee Mile Report Line	6
Start Levee Mile	1.26
End Levee Mile	1.32
Location	Land Side
Category	Earthen Levee
Item	Encroachments
Barbed wire fence on levee toe.	
jpaasch_20091002_1.jpg
